Quality Assurance/Quality Control (QA/QC) and Additional Deliverables for Los Angeles Region Imagery Acquisition Consortium (LAR-IAC4)

David Maune, PhD., CP, CFM, PSM, PS, GS, SP Dewberry & Davis Services Operations, Inc.

February 6, 2014

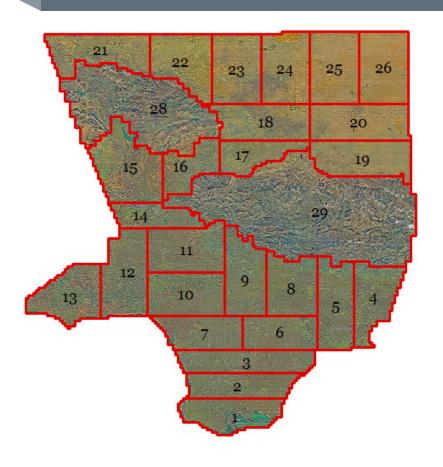
Aerial Triangulation (AT) Blocks

AT blocks must pass Dewberry's QA/QC before production of digital orthophotos can begin.
